**AIRCRAFT
ACCIDENT
REPORT**
Trans World Airlines Flight 800
Part I
Consideration of Reasonable Probable Causes

**Report on the accident to
Trans World Airlines Flight 800
Boeing 747-131, N93119
Near East Moriches, New York
July 17, 1996
by John Barry Smith,
Independent Aircraft Accident Investigator**

Part I: Consideration of Reasonable Probable Causes

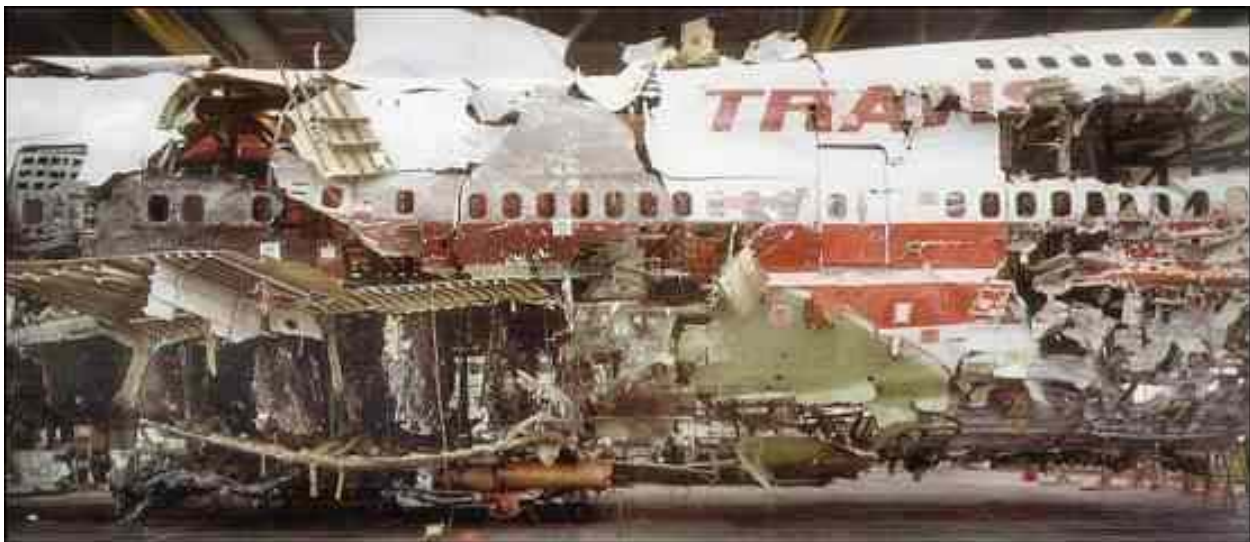
Right front and middle of Trans World Airlines Flight 800 revealing sharp sooted and non sooted cut in fuselage, nose to right.

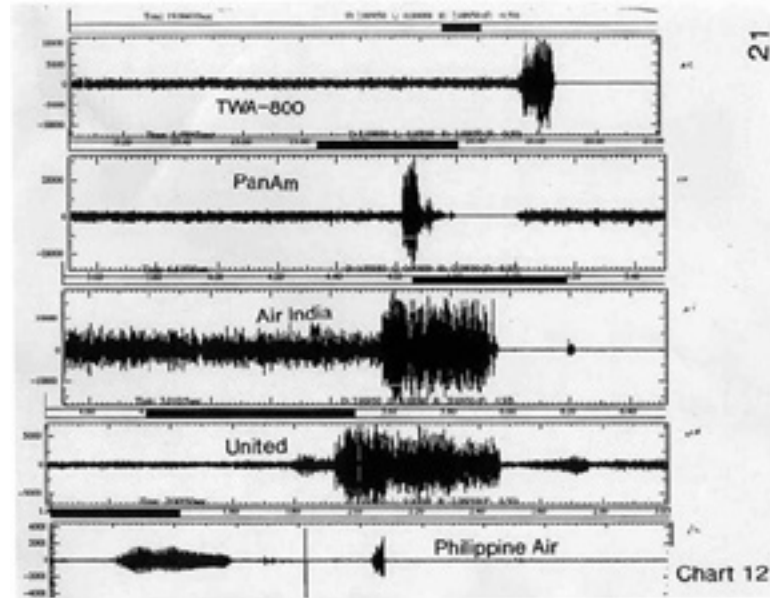
Above Chart 12 from TWA 800 Public Docket for TWA 800 and shows CVR data for TWA 800, Pan Am Flight 103, Air India Flight 182, United Airlines Flight 811, and a Philippines Airlines 737.

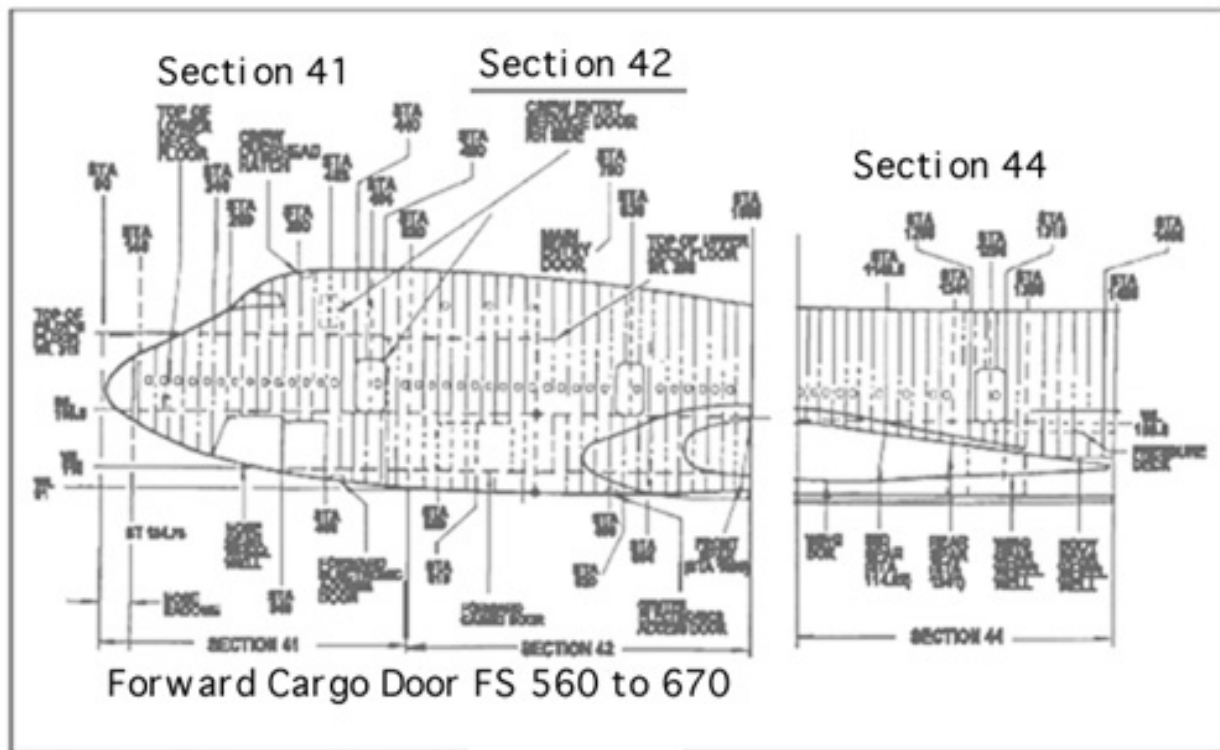
Figure 3a. Locator of fuselage sections 41, 42, and 44.

Above is a drawing from NTSB AAR 00/03 showing fuselage station numbers and sections.

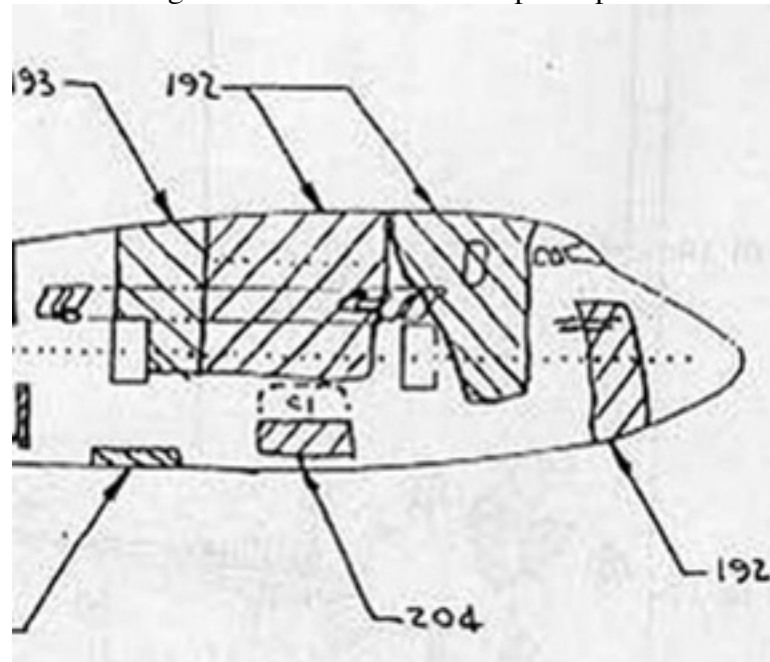
Excerpts of official corroborative drawings and photographs to support all aircraft had similar shattered skin in and around the forward cargo door. Air India Flight 182 from the Indian Kirpal Report:

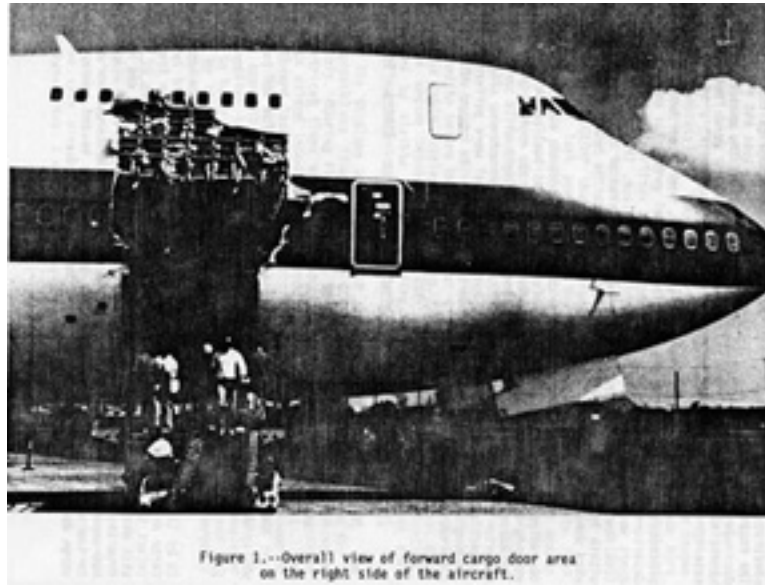
Figure 1.--Overall view of forward cargo door area on the right side of the aircraft.

United Airlines Flight 811: From NTSB AAR 92/02: 1.3 Damage to the Airplane
 The primary damage to the airplane consisted of a hole on the right side in the area of the forward lower lobe cargo door, approximately 10 by 15 feet large. The cargo door fuselage cutout lower sill and side frames were intact but the door was missing (see figures 1 and 2). An area of fuselage skin measuring about 13 feet lengthwise by 15 feet vertically, and extending from the upper sill of the forward cargo door to the upper deck window belt, had separated from the airplane at a location above the cargo door extending to the upper deck windows. The floor beams adjacent to and inboard of the cargo door area had been fractured and buckled downward. Examination of all structure around the area of primary damage disclosed no evidence of preexisting cracks or corrosion. All fractures were typical of fresh overstress breaks. Debris had damaged portions of the right wing, the right horizontal stabilizer, the vertical stabilizer and engines Nos. 3 and 4. No damage was noted on the left side of the airplane, including engines Nos. 1 and 2.

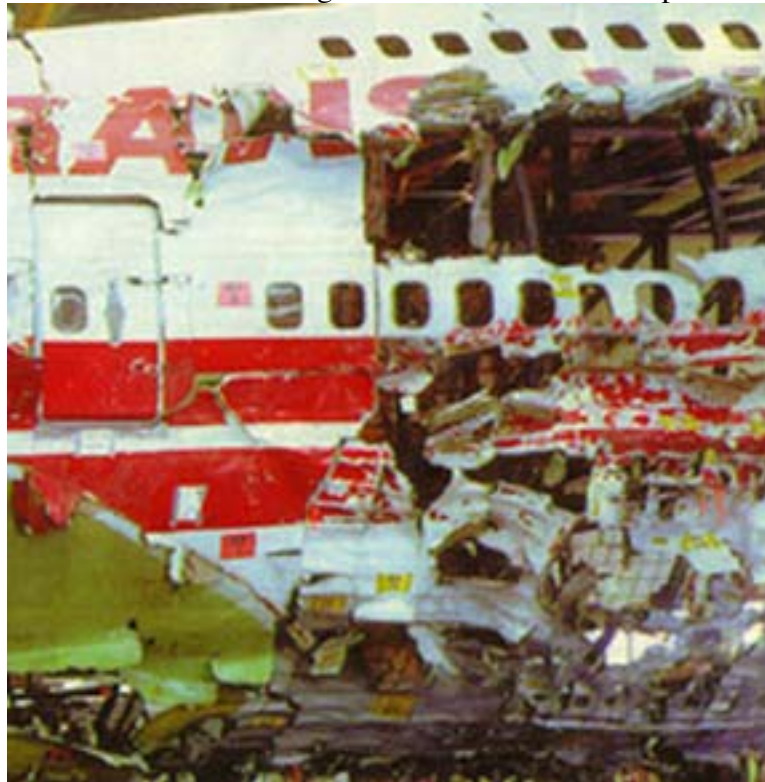
Trans World Airlines Flight 800 photographs show the ruptured, split and shattered forward cargo door.

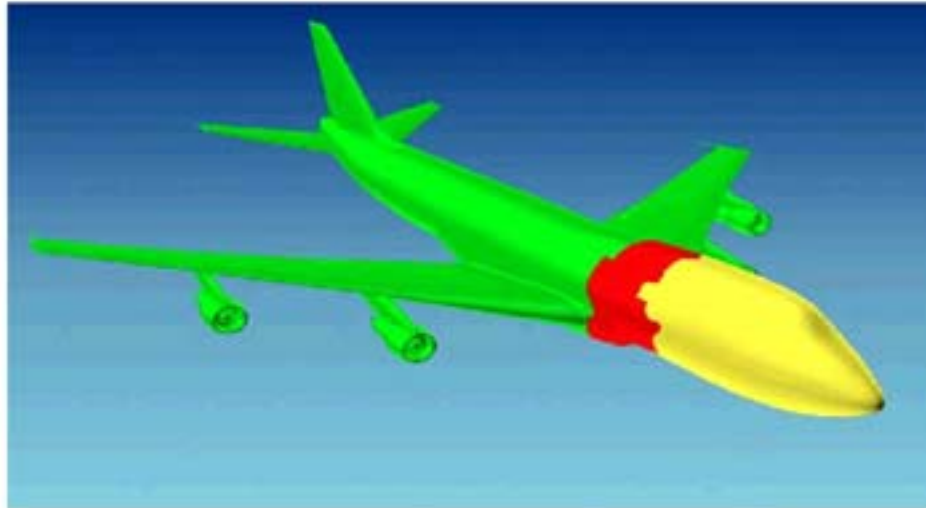
Below illustration shows the red zone of Trans World Airlines Flight 800 which is where all the first debris left the aircraft. The red zone includes the forward cargo door area but the zone is forward of the center fuel tank.

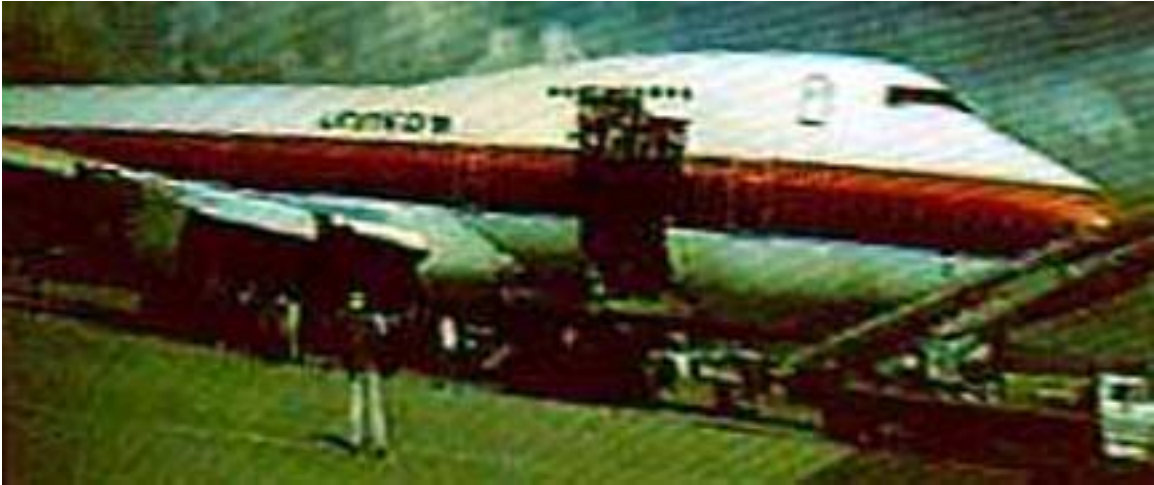
Photo of hole in United Airlines Flight 811 made by inadvertent opening of forward cargo door in flight. Note rectangular shape.

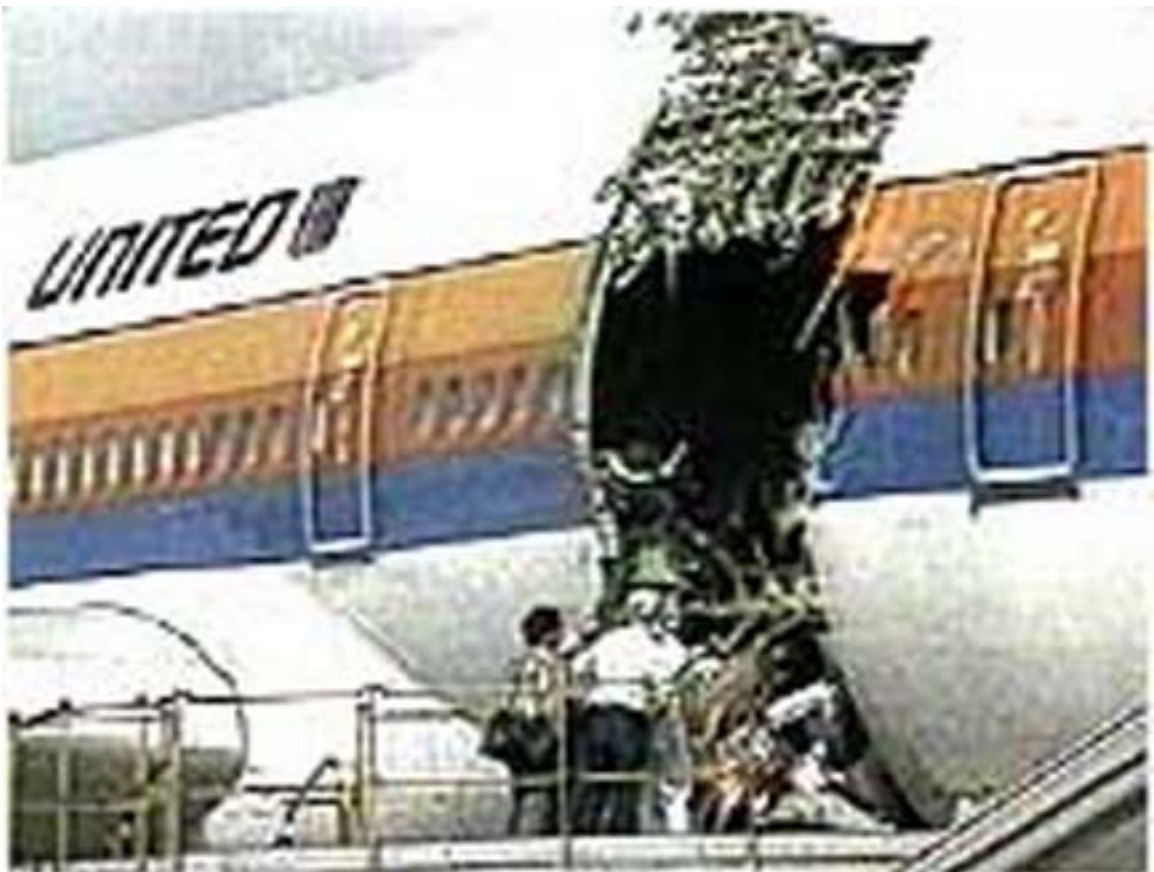
Photo of hole in United Airlines Flight 811 made by inadvertent opening of forward cargo door in flight.

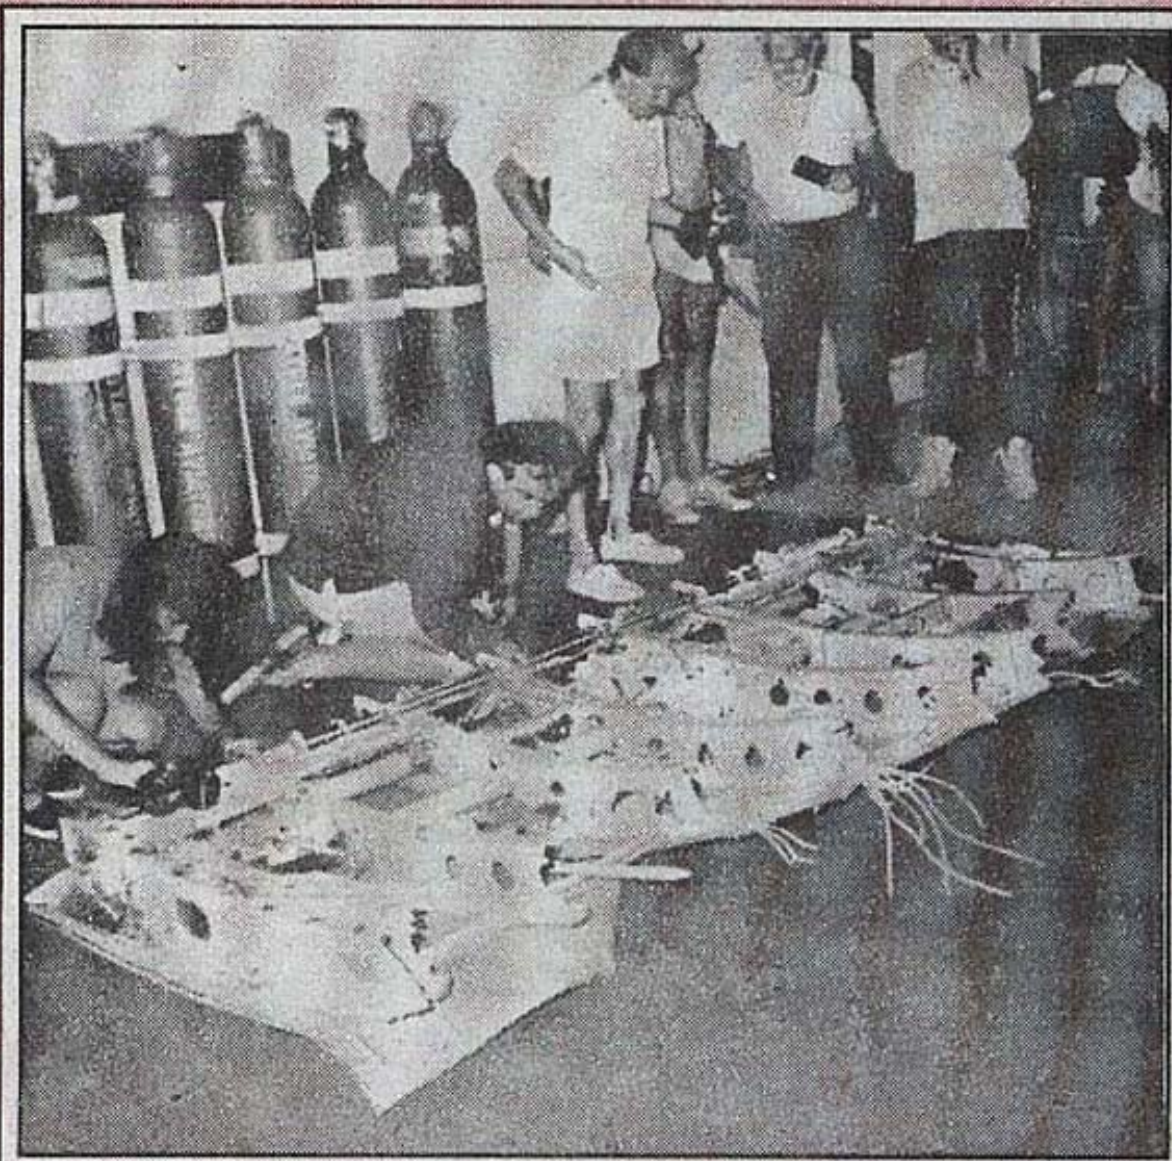
The bottom half of the cargo door from United Flight 811 is examined on board a Navy contract support ship after it was retrieved from a depth of nearly three miles. The crew of the mini-sub Sea Cliff hopes to recover the top half this weekend. See story on Page A3.

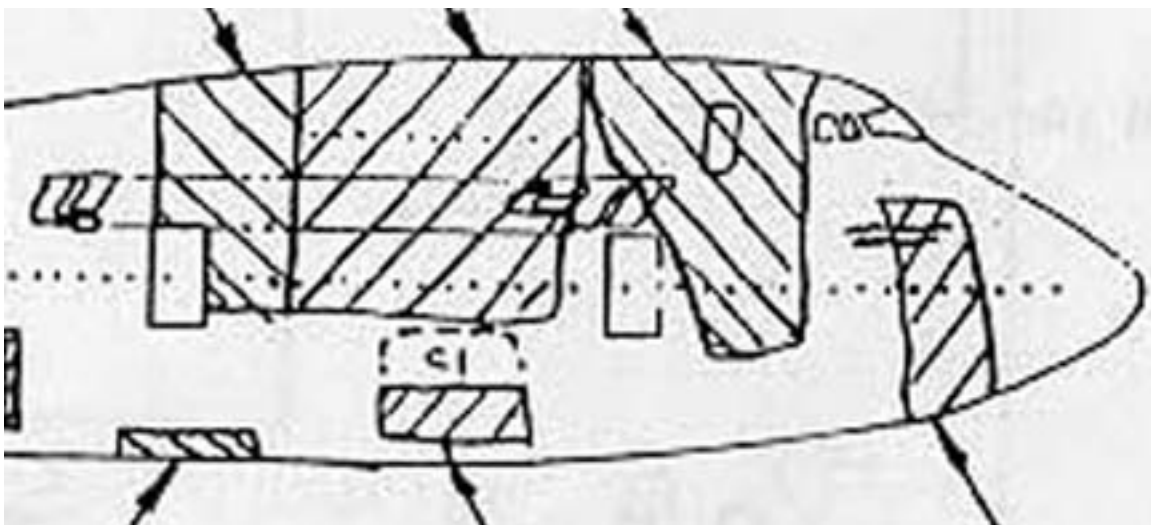
Reconstruction drawing from the Kirpal Report and the CASB report on Air India Flight 182 showing the longitudinal split of the forward cargo door and the vertical tearing of the skin above the door.

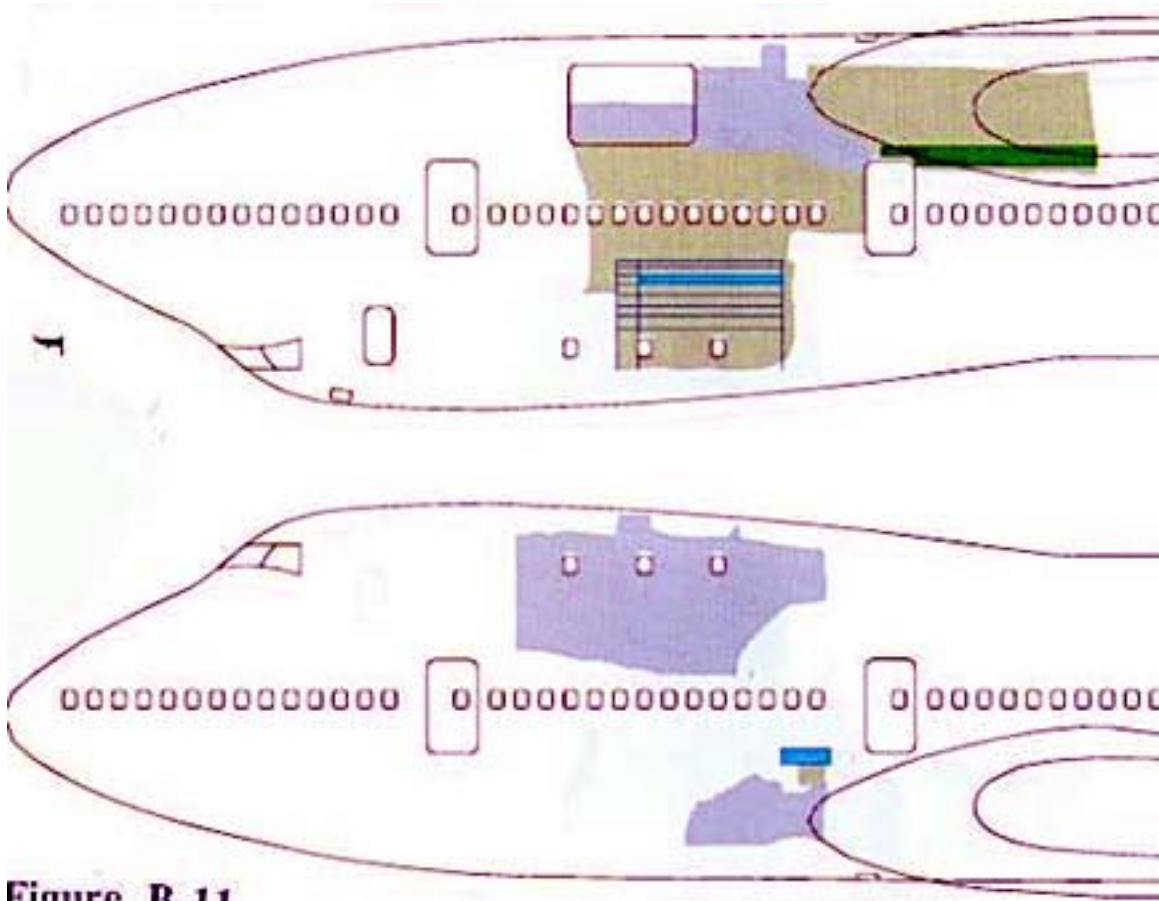
Figure B-11

Figure B11 from AAIB 2/90 for Pan Am Flight 103 showing initial event time fuselage destruction with small 'bomb' hole rectangle on port side and huge rectangular destruction around forward cargo door on starboard side.

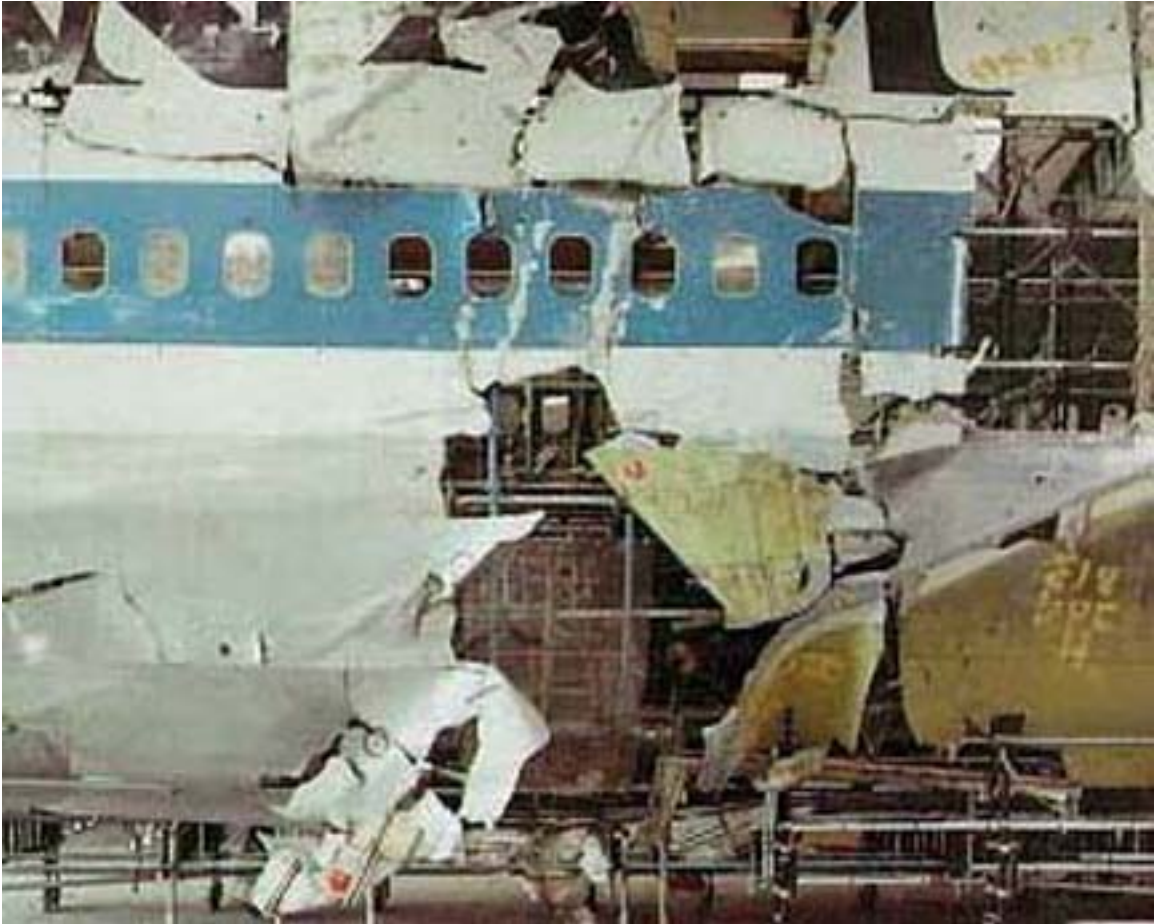
Port side of Pan Am Flight 103 forward of the wing showing the small 'bomb' hole and relatively smooth and intact fuselage skin around it.

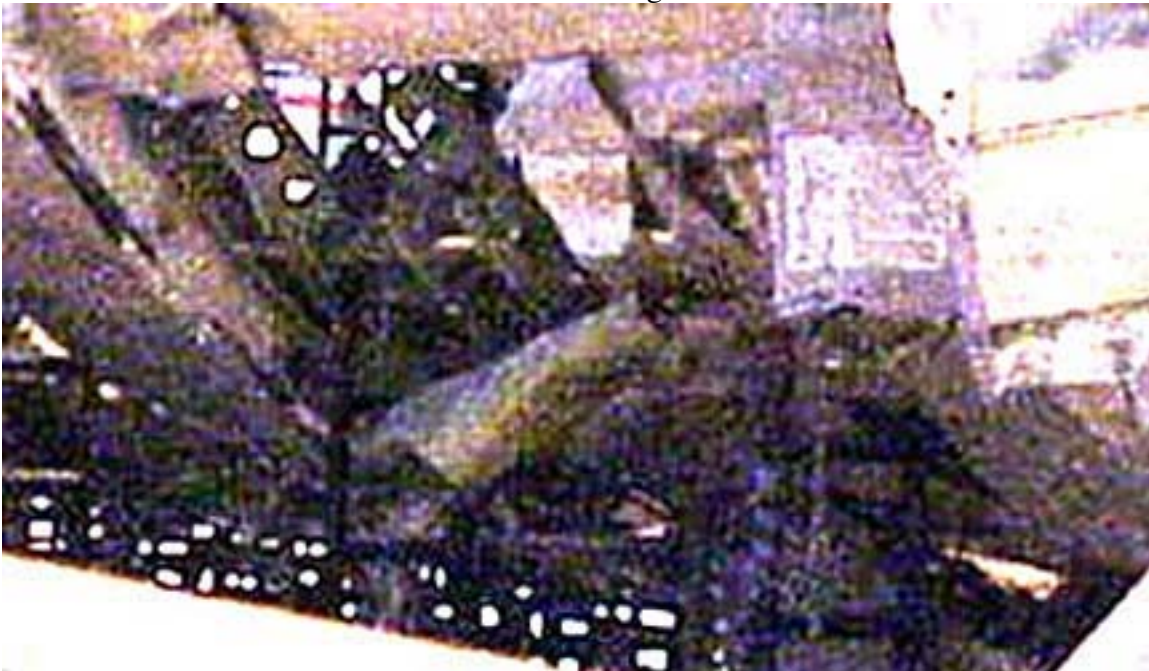
Closeup of the peeled back and down skin from the aft midspan latch of PA 103 forward cargo door.

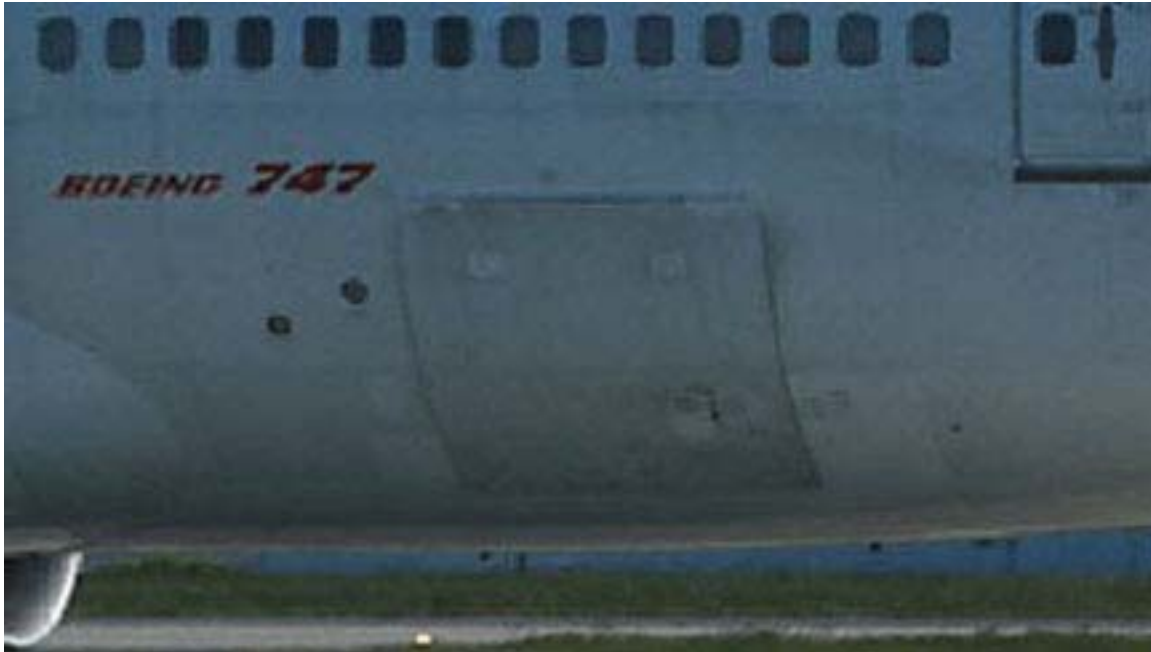
Normal Boeing 747 forward cargo door showing aft and forward pressure relief doors near top hinge.

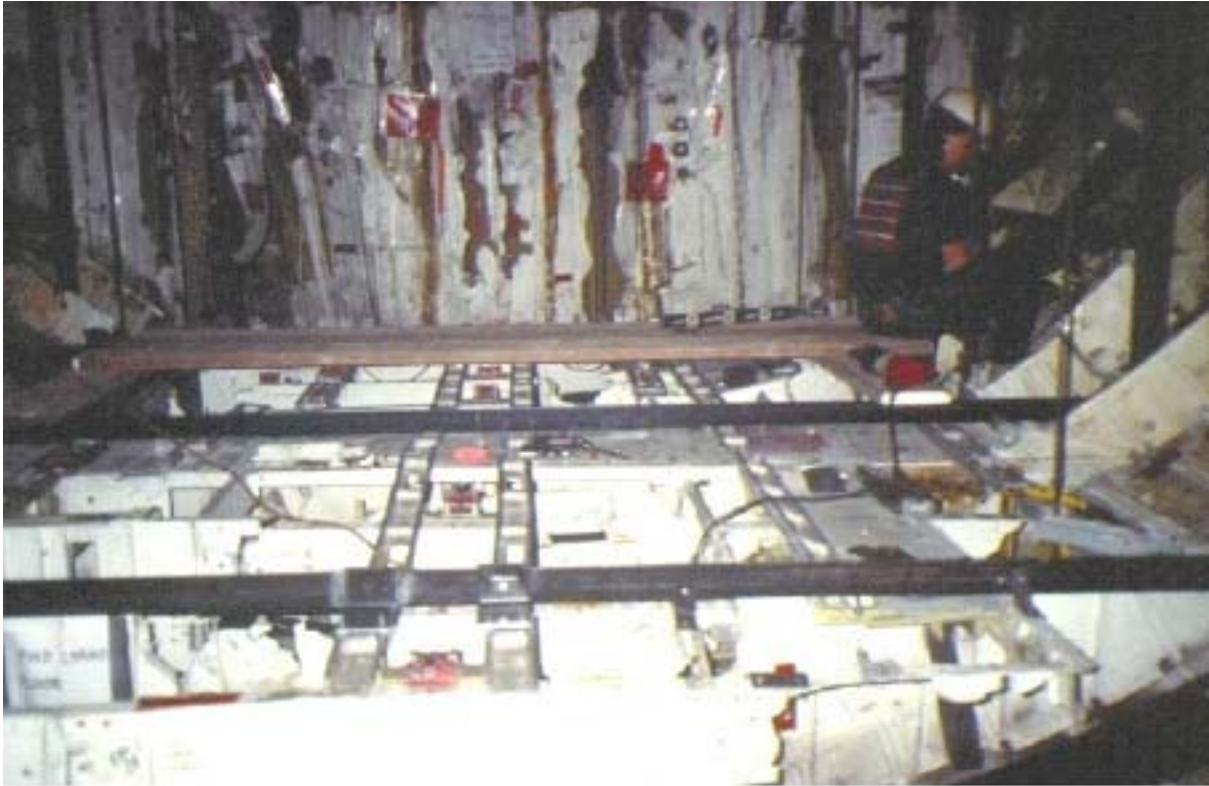
The front cargo bay area in the red zone

Red zone is area where pieces departed Trans World Airlines Flight 800 first.

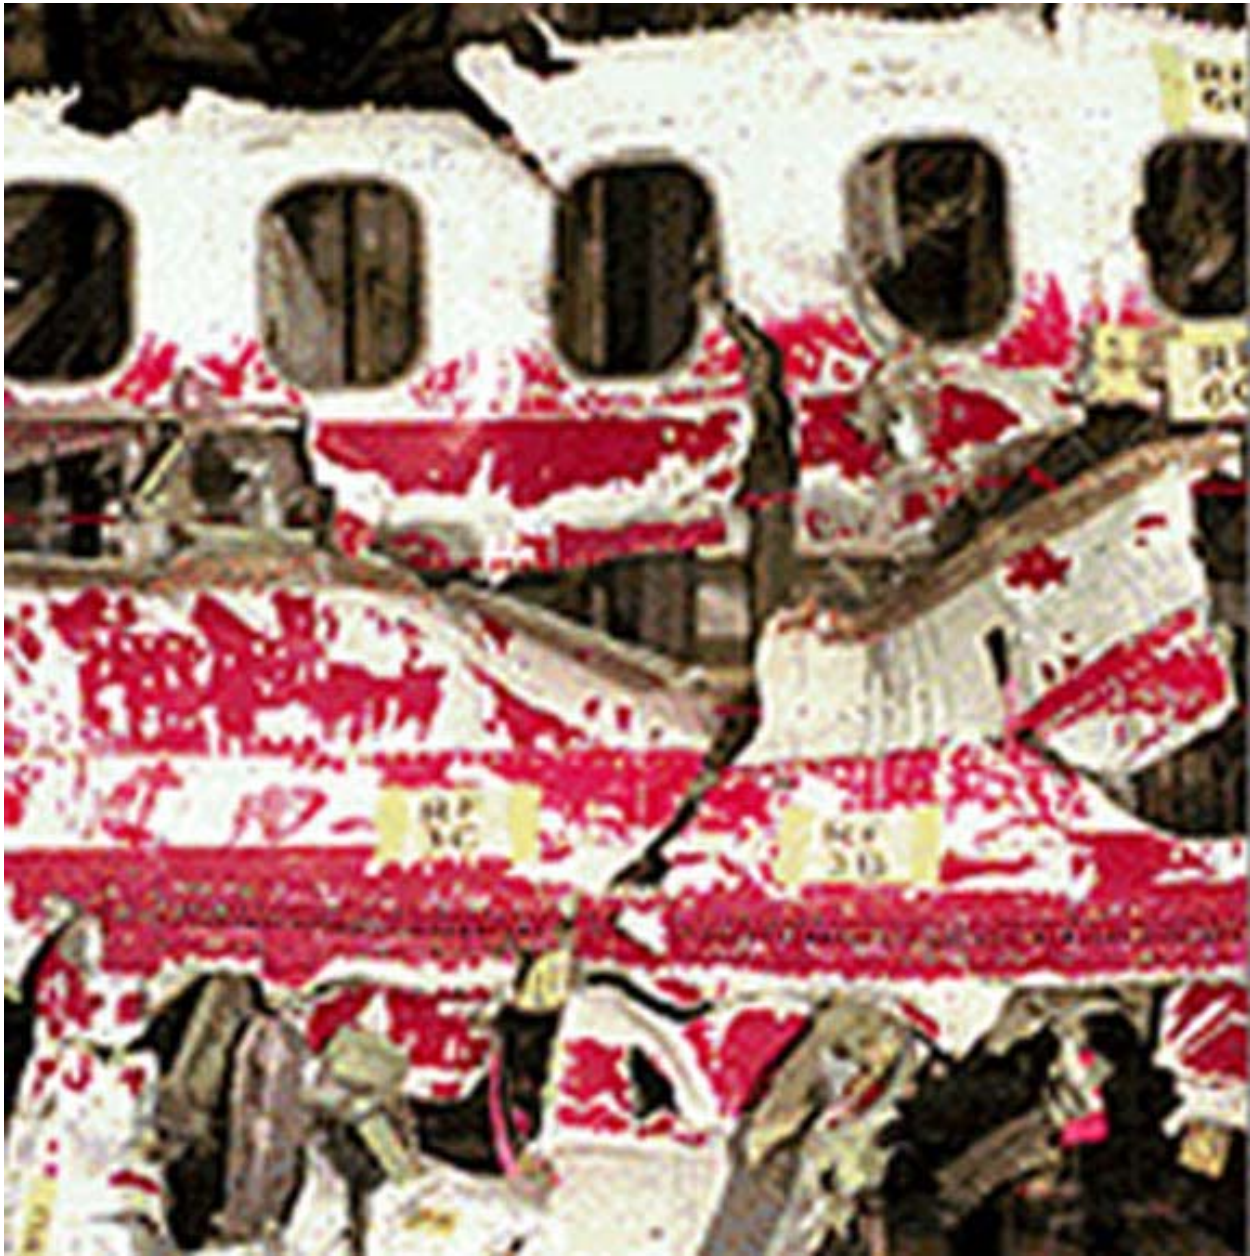
Right side above forward cargo door hinge, nose to right.

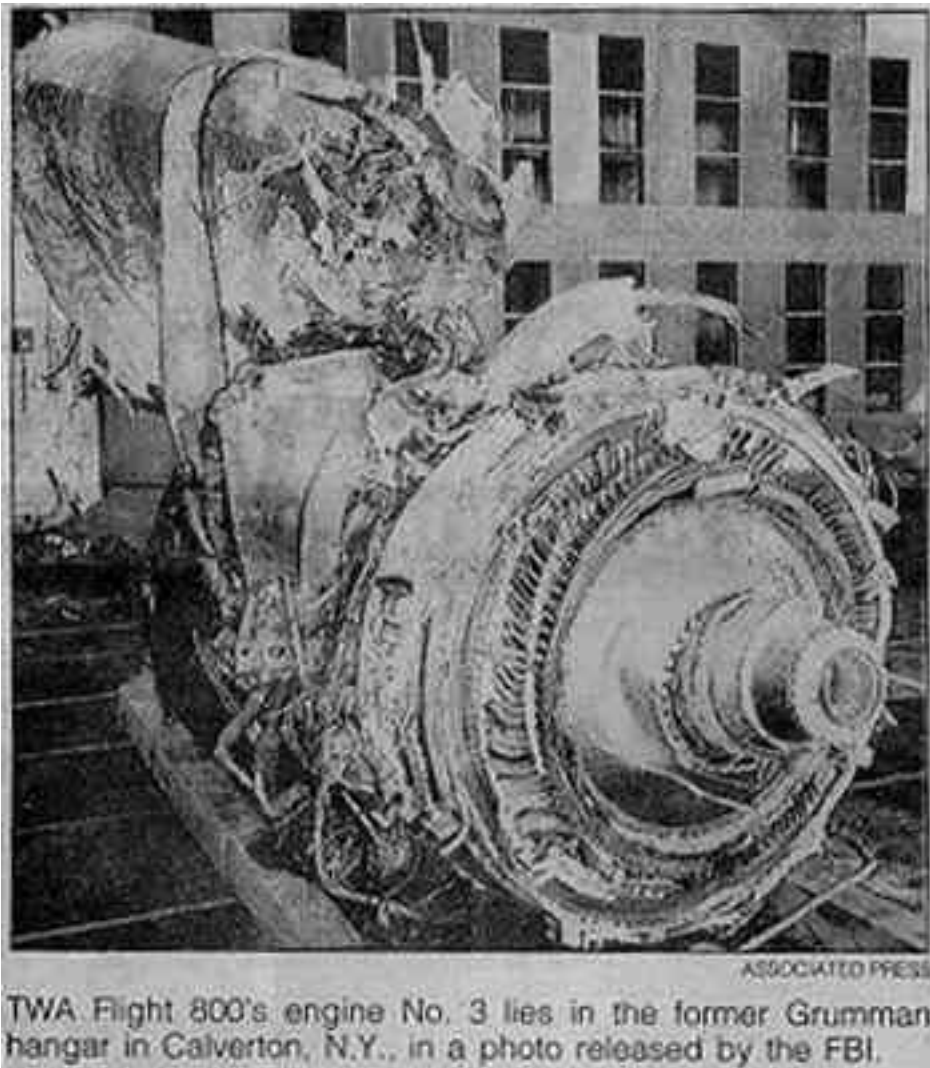
3. Engine number three was uncontained, missing blades, and sooted:

The most probable answer to this observation is offered by the shorted wiring/forward cargo door rupture/explosive decompression/inflight breakup explanation in which the starboard forward cargo door ruptures open in flight and ejects cargo bay material, passengers and their seats out into the slipstream on the starboard side. The debris gives the shattered appearance to a forty foot by

thirty foot rectangle of skin, foreign object damage to engine number three, inflight damage to the right wing leading edge and also to the right horizontal stabilizer.

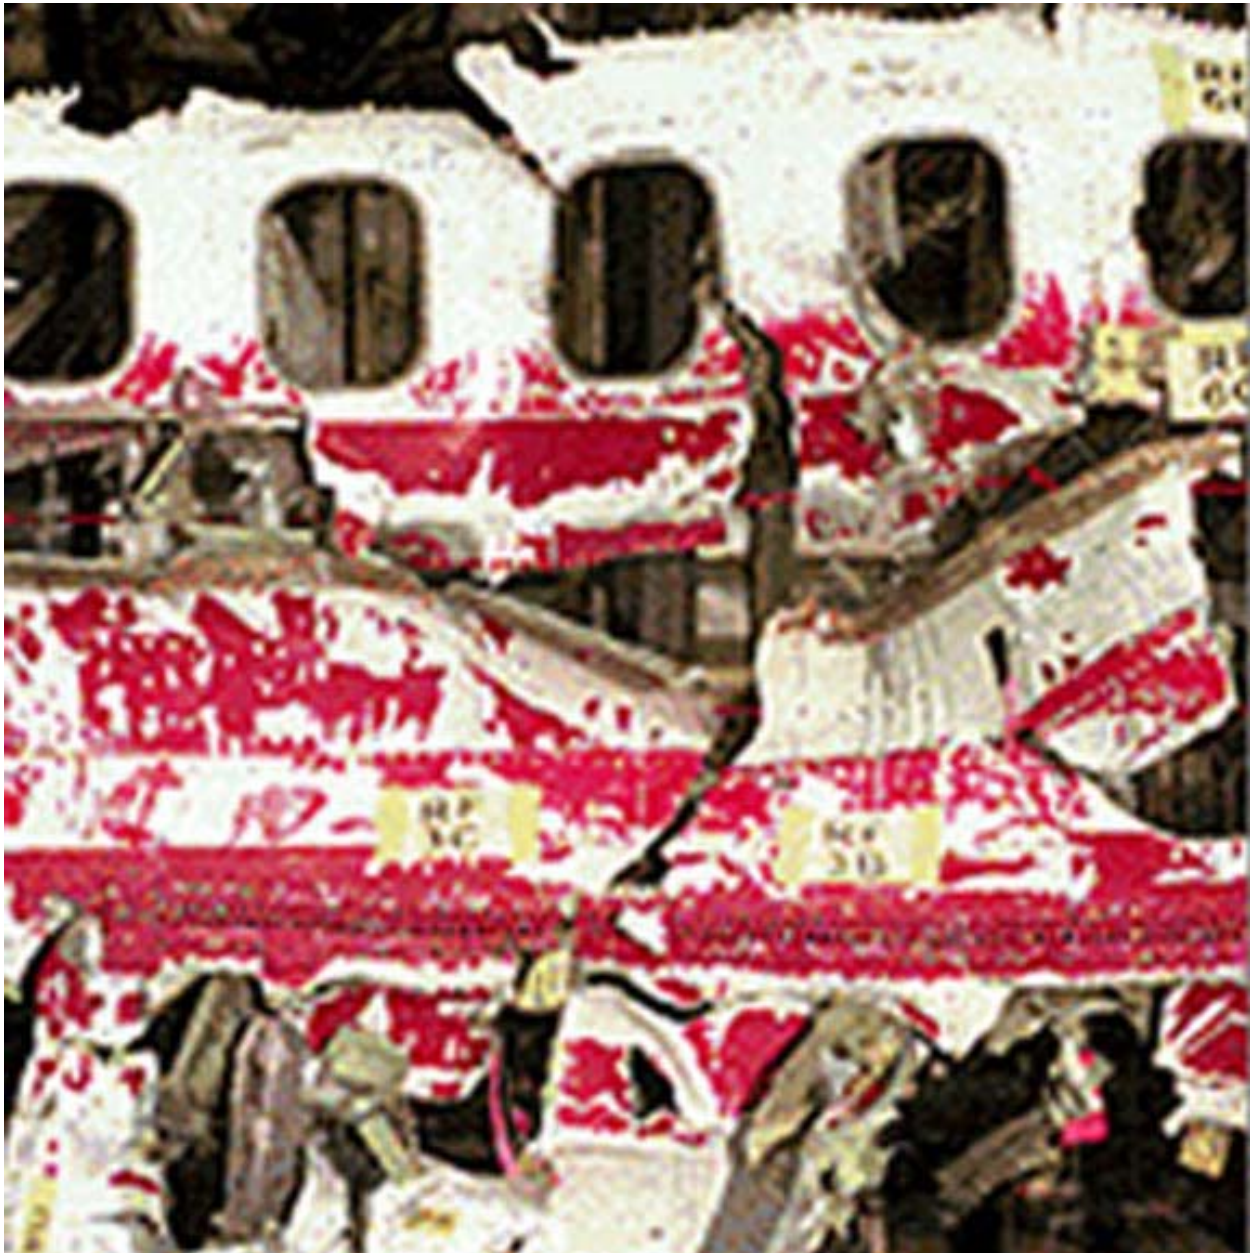
The probable explanation is that when the forward cargo door ruptured open in flight, the top half of the door blew open, outward, up, and slammed into the fuselage skin above it, transferring paint from the door to the fuselage and vice versa. The red paint smears reveal there was some contact from the fuselage skin below to create the disrupted paint scheme.

To put it another way; after the rupture at aft midspan latch the door fractured and the upper piece of the red painted door was pushed outward, rotated on its hinge, slammed upward and smashed into the white painted fuselage skin above, transferring red paint to the white painted area between the passengers windows, as shown by the TWA 800 reconstruction. UAL 811 also had paint transfer from door to fuselage when its door opened in flight.

There is no discussion of this important evidence in any of the NTSB reports.

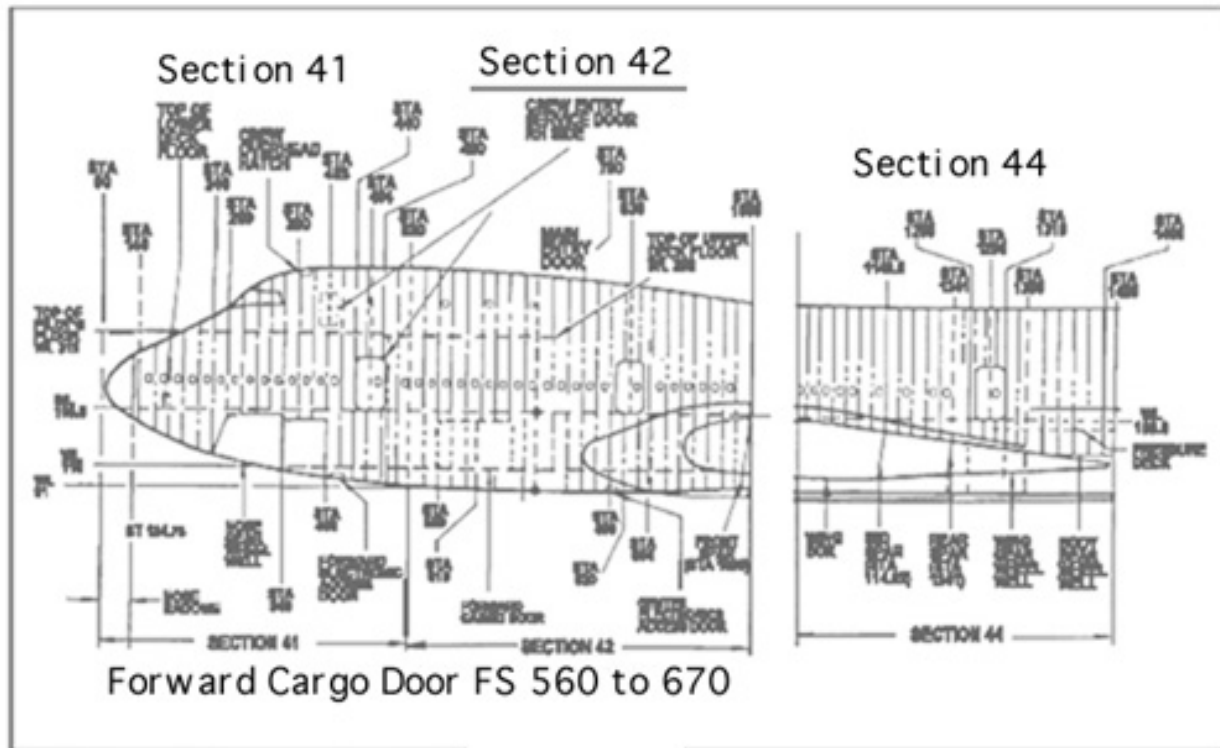
Figure 3a. Locator of fuselage sections 41, 42, and 44.

Above is a drawing from NTSB AAR 00/03 showing fuselage station numbers and sections.

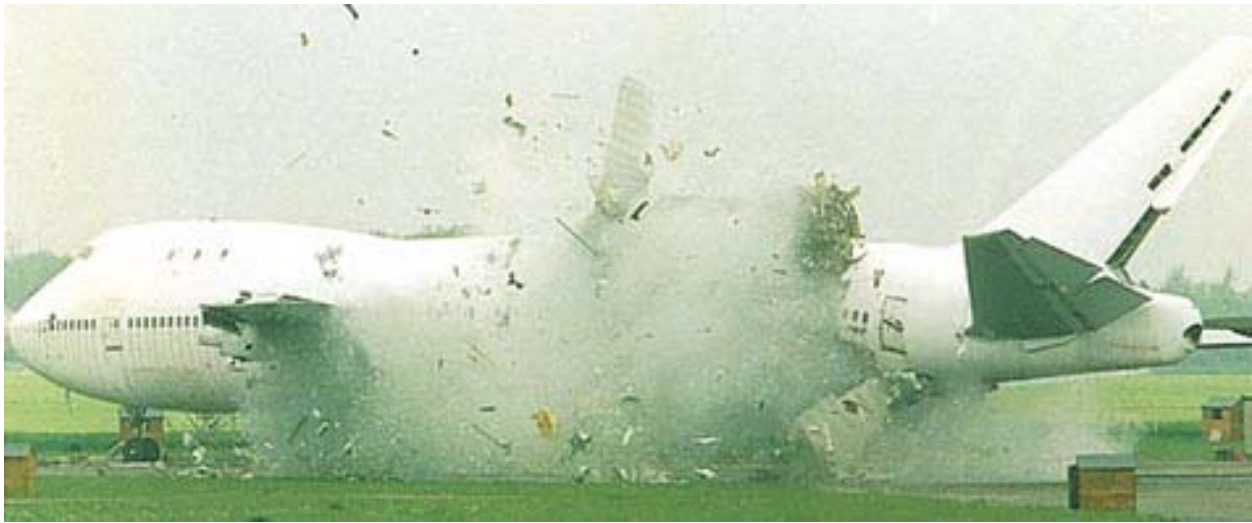
Above is a picture of the staged bombing of a Boeing 747 at Bruntingthorpe in 1997.

The aft section evidence which resulted from the real bomb explosion above does not match the aft section evidence examined for Air India Flight 182 which had undeformed, straight fuselage skin and intact cargo doors. If the above bomb type explosion had occurred in Air India Flight 182, the Canadian and Indian and UK investigative authorities in 1985/1986 would most certainly have detected it because of the obvious hot-gas pitting on pieces of metal, punctures, shrapnel, explosive residue, pitting, cratering, explosive type injuries to passengers sitting in the cabin, timer, fuze, and a bomb explosion sound on the cockpit voice recorder.

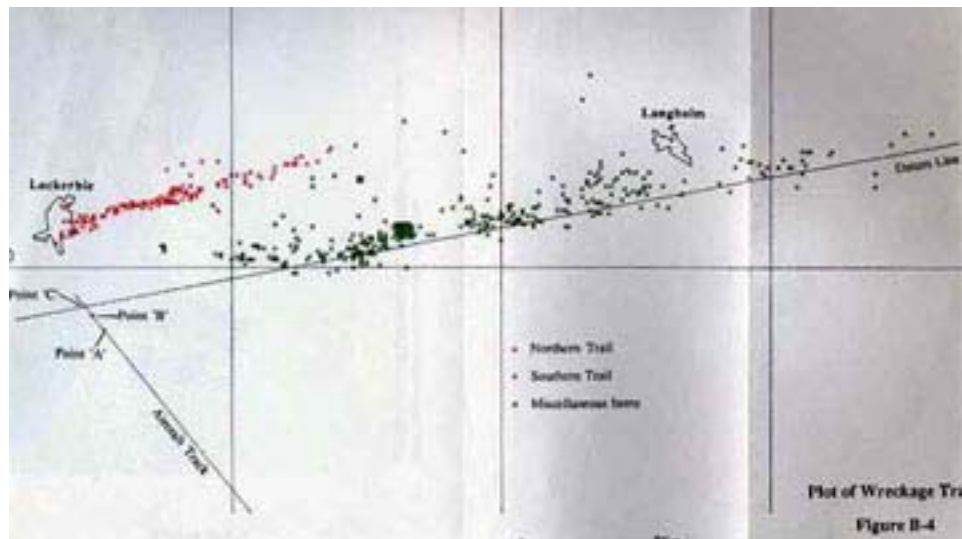
Above drawing shows wreckage trails for Pan Am Flight 103 from the AAIB AAR 2/90

The debris patterns of Air India Flight 182 and Pan Am 103 do match. Both events were carefully examined for the location of the explosion that broke the aircraft apart amidships. Both events have conclusive evidence of an explosion in the forward cargo compartment to explain the breakup. Both events had none of the evidence to support an assertion of an explosion from any source in the aft cargo compartment. The matching debris patterns of both events confirm the conclusions of the British, Indian, and Canadian investigators who stated in their respective aircraft accident reports that the explosion in each aircraft occurred in the forward cargo compartment and did not occur in the aft compartment.

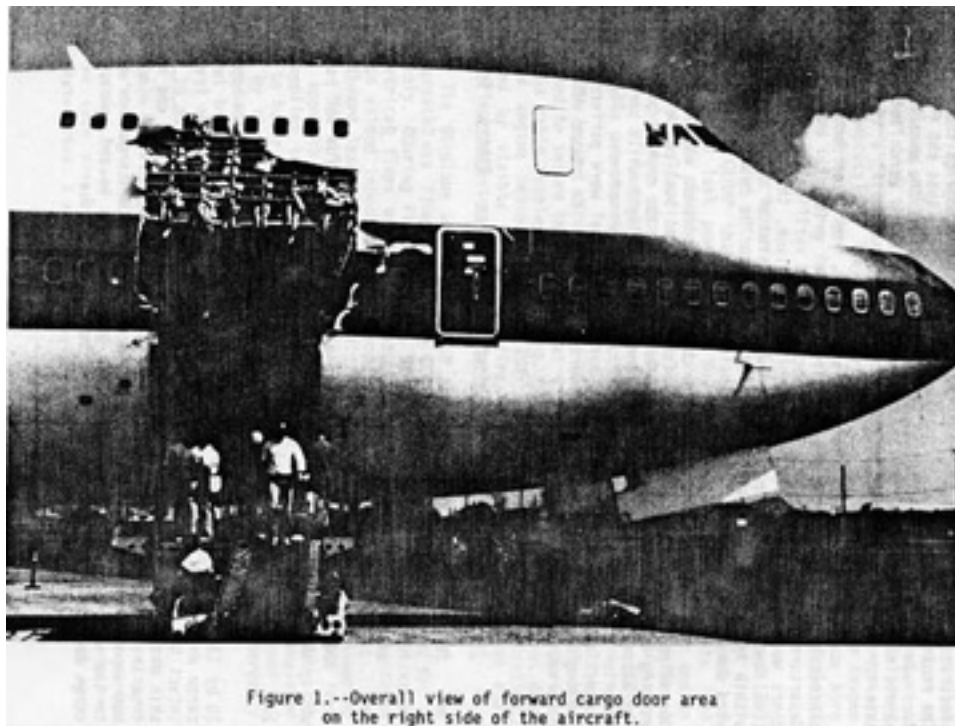
On February 24, 1989, United Airlines Flight 811, a Boeing 747-122, experienced an explosive decompression as it was climbing between 22,000 and 23,000 feet after taking off from Honolulu, Hawaii, en route to Sydney, Australia with 3 flightcrew, 15 flight attendants, and 337 passengers aboard.

'The National Transportation Safety Board determines that the probable cause of this accident was the sudden opening of the improperly latched forward lower lobe cargo door in flight and the subsequent explosive decompression.' NTSB also stated: 'The next opportunity for the FAA and Boeing to have reexamined the original assumptions and conclusions about the B-747 cargo door design and certification was after the findings of the Turkish Airline DC-10 accident in 1974 near Paris, France. The concerns for the DC-10 cargo door latch/lock mechanisms and the human and mechanical failures, singularly and in combination, that led to that accident, should have prompted a review of the B-747 cargo door's continuing airworthiness. In the Turkish Airlines case, a single failure by a ramp service agent, who closed the door, in combination with a poorly designed latch/lock system, led to a catastrophic accident. The revisions to the DC-10 cargo door mechanisms mandated after that accident apparently were not examined and carried over to the design of the B-747 cargo doors. Specifically, the mechanical retrofit of more positive locking mechanisms on the DC-10 cargo door to preclude an erroneous locked indication to the flightcrew, and the incorporation of redundant sensors to show the position of the latches/locks, were not required to be retrofitted at that time for the B-747.'

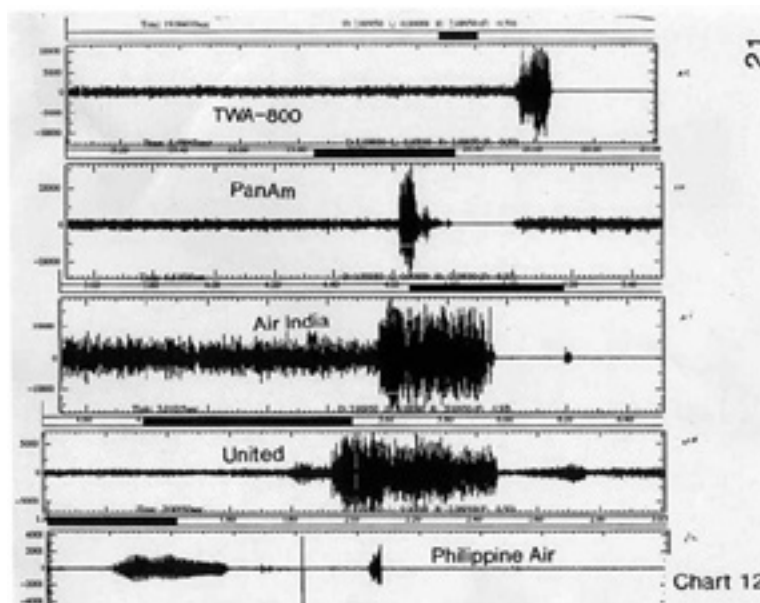
Above Chart 12 from TWA 800 Public Docket for TWA 800 and shows CVR data for TWA 800, Pan Am Flight 103, Air India Flight 182, United Airlines Flight 811, and a Philippines Airlines 737.

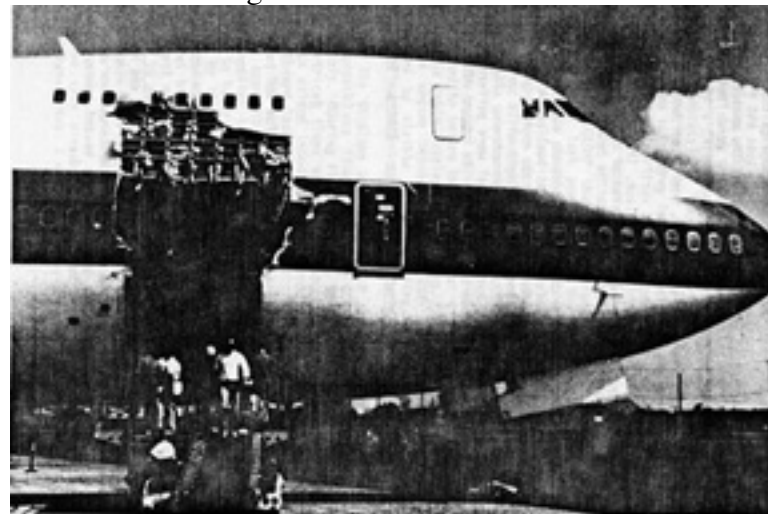
Figure 1.--Overall view of forward cargo door area on the right side of the aircraft.

The primary damage to the airplane consisted of a hole on the right side in the area of the forward lower lobe cargo door, approximately 10 by 15 feet large. The cargo door fuselage cutout lower sill and side frames were intact but the door was missing (see figures 1 and 2). An area of fuselage skin measuring about 13 feet lengthwise by 15 feet vertically, and extending from the upper sill of the forward cargo door to the upper deck window belt, had separated from the airplane at a location above the cargo door extending to the upper deck windows. The floor beams adjacent to and inboard of the cargo door area had been fractured and buckled downward.

United Airlines Flight 811 below from NTSB AAR 92/02
